FireGuard

Ceramic Mortar Joint & Resurfacing System

The Solution

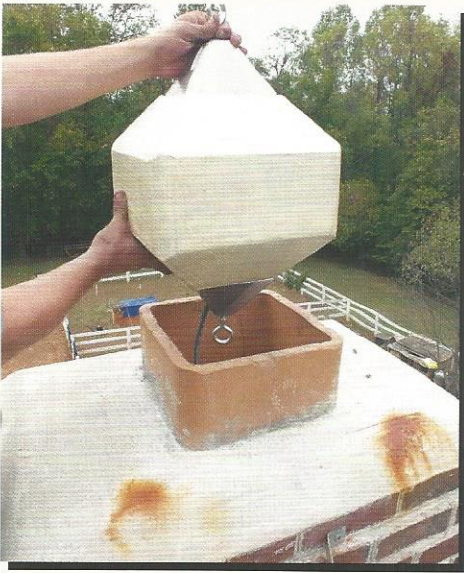
(1) A closed-cell applicator with an internal vibrator is installed in the top of the flue and winched down to the base of the flue.

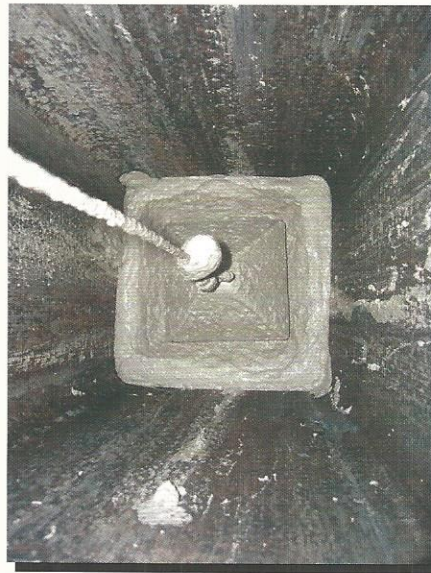
(2) The **FireGuard** material is then blended and poured on top of the vibrating applicator as it is winched up the flue. The applicator is drawn up and down the flue for multiple passes.

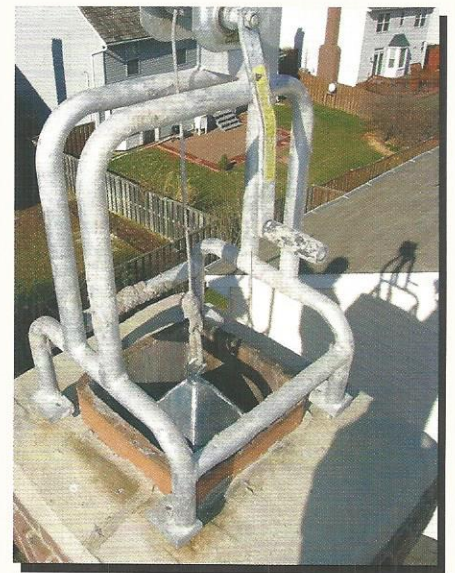
(3) Top winch is used to pull the vibrating applicator up the flue.

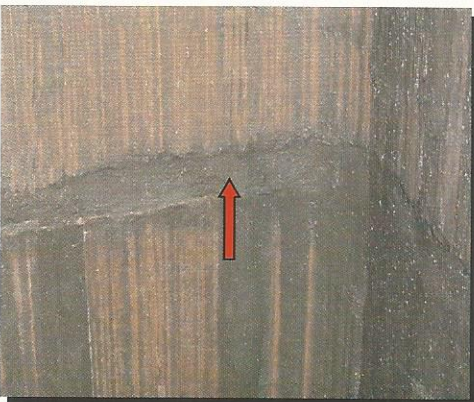
1" open mortar joint solidly filled.

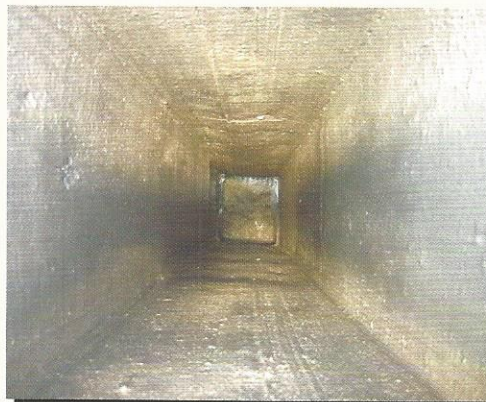
Fractured flue liners completely resurfaced.

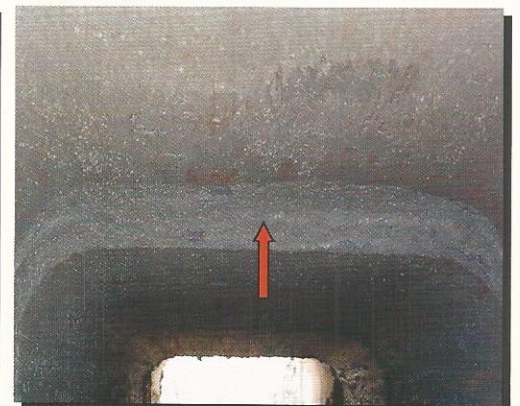
1" off-set between flue liners solidly filled.

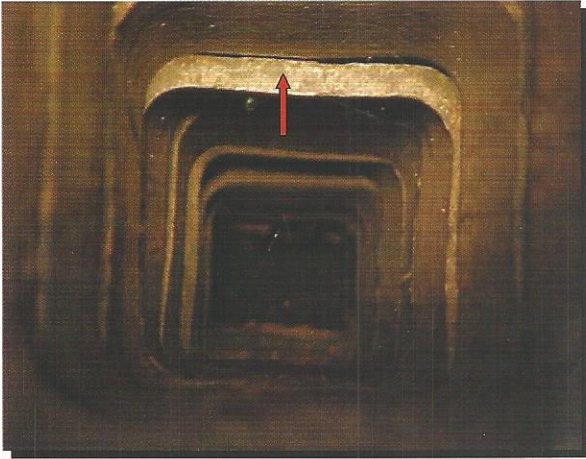
(1) Misaligned flue liners.

During original construction of a masonry chimney, it is not uncommon for masons to improperly align the flue liners or neglect to fill the joints between the flue liners with the appropriate refractory mortar (images 1 & 2). As stated in the 2006 International Residential Code, R1003.12 Flue lining (installation): "Fireclay flue liners shall be laid in medium-duty refractory mortar conforming to ASTM C 199 with tight mortar joints left smooth on the inside..." Additionally, thermal shock caused by chimney fires or over-firing of an appliance or fireplace causes clay flue liners to fracture (image 3). Settling or seismic vibration during an earthquake also causes flue liners to shift and fracture.

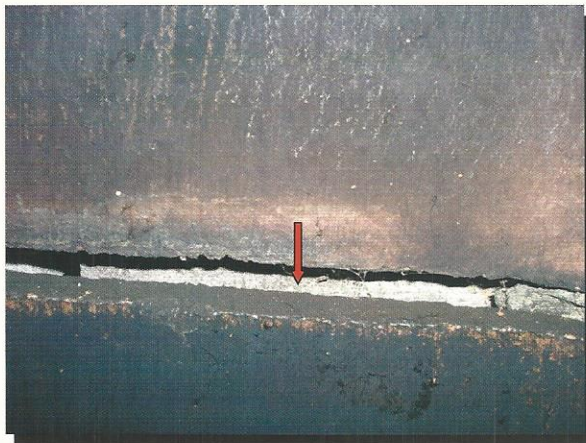
(2) Gap between flue liners as viewed through electronic scanner.

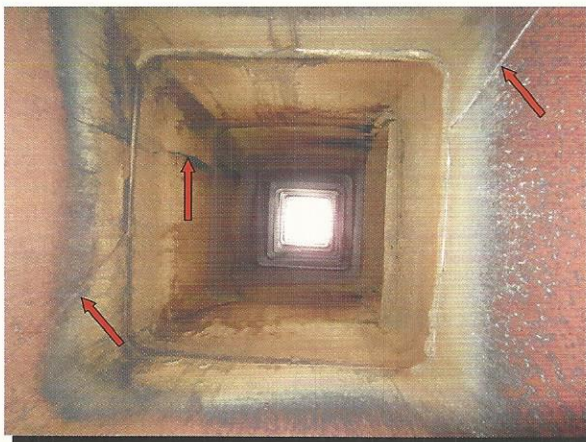
(3) Fractured flue liners.
